**Flood Control Project Maintenance
Levee Inspections**

Fall 2013 Levee Maintenance Deficiency Summary Report

Reclamation District No. 1601 Twitchell

Waterway			Bank	Unit Miles
Unit No. 01 Threemile Slough			Left	2.47
	Spring (March - May)	Summer (June - August)	(September - November) Fall	Winter (December - February)
Unit Maintenance Rating (Fall Only)			A	
Date of Inspection	03/14/2013 - 03/14/2013		09/12/2013 - 09/12/2013	
DWR Inspector	Richard Willoughby		Richard Willoughby	
Accompanied By

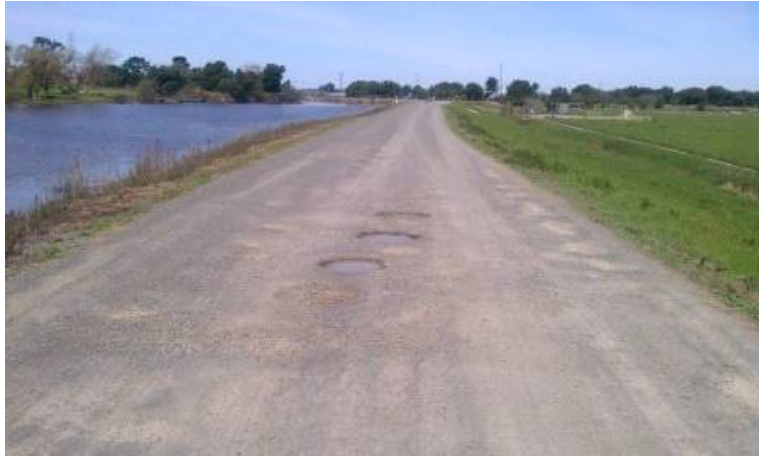
Levee Mile Report Line	4
Start Levee Mile	0.10
End Levee Mile	2.47
Location	Crown
Category	Earthen Levee
Item	Crown Surface / Depressions / Rutting
Looking north at holes on levee crown.	
richard_f_20130911_209.jpg

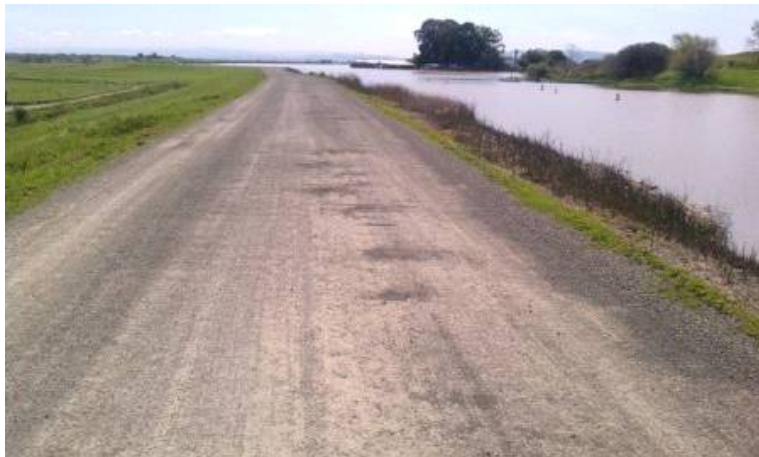
Levee Mile Report Line	4
Start Levee Mile	0.10
End Levee Mile	2.47
Location	Crown
Category	Earthen Levee
Item	Crown Surface / Depressions / Rutting
Looking south at crown surface rutting.	
richard_f_20130911_210.jpg

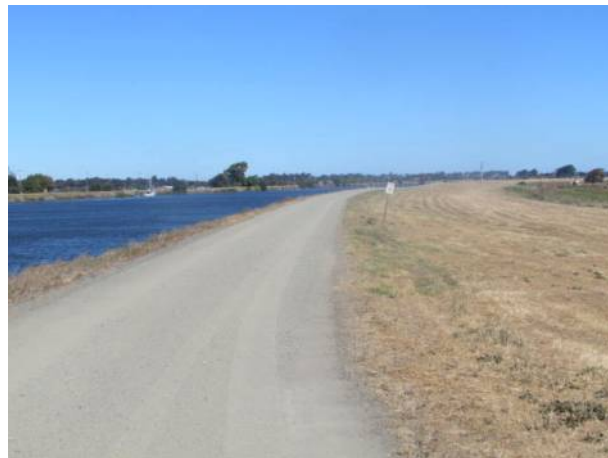
Levee Mile Report Line	4
Start Levee Mile	0.10
End Levee Mile	2.47
Location	Crown
Category	Earthen Levee
Item	Crown Surface / Depressions / Rutting
Looking southwest at re-grade crown roadway.	
richard_f_20130911_211.JPG

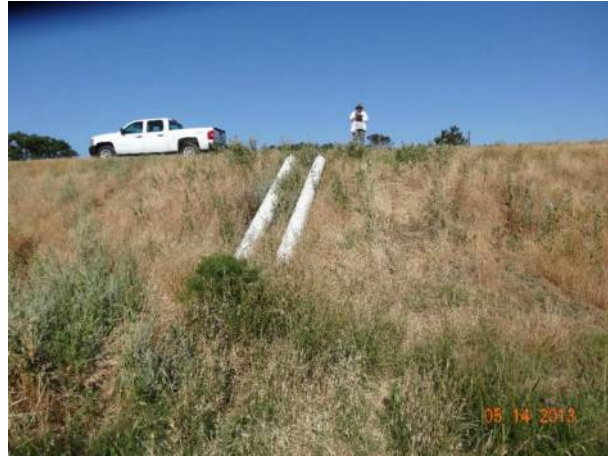
DWR ID: DWR_RD1601_01_f_2013_1										
6	0.11	0.11	Supplemental	DWR UCIP Field Study	CR	M En	Inspector Comments: FS_ID:19526 EP_NO: 11227 Repair Type: Non-Urgent Crossing Status: Found UCIP Comments: FIELD_STRUCT_DESC: 12-inch pipe through the levee, 4.0 feet below the crown. Siphon primer on waterward shoulder. 36-inch steel pipe with shut-off valve inside at landward toe ditch. (ABO No. 11227-1975) FS Date: 05/14/2013	38.120716 ° -121.682796 °	38.120716 ° -121.682796 °	2 Y
DWR ID: DWR_RD1601_01_f_2013_2

Levee Mile Report Line	6
Start Levee Mile	0.11
End Levee Mile	0.11
Location	Crown
Category	Supplemental
Item	DWR UCIP Field Study
View of pipes located on landward side-dense vegetation along slope.	
UCIP_11816.jpg

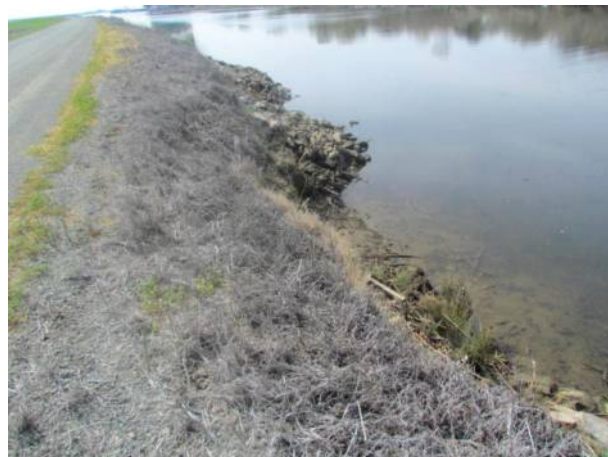
LMR No.	Levee Mile		Category	Item	Location *	Rating **	Action/Comment	GPS Latitude/Longitude		Issue No. Photo
	Start	End						Start	End	
15	0.17	0.17	Earthen Levee	Erosion / Bank Caving	CR	A Ma	E1 : Note and monitor erosion site. Inspector Comments: District repaired site.	38.119832 ° -121.682762 °	38.119832 ° -121.682762 °	4 Y
DWR ID: DWR_RD1601_01_s_2013_4										
16	0.18	0.18	Earthen Levee	Erosion / Bank Caving	CR	M Ma	E1 : Note and monitor erosion site. Inspector Comments: District repaired site.	38.119698 ° -121.682760 °	38.119698 ° -121.682760 °	3 Y
DWR ID: DWR_RD1601_01_s_2013_3										
17	0.80	0.80	Supplemental	DWR UCIP Field Study	CR	M En	Inspector Comments: FS_ID:19510 EP_NO: N/A Repair Type: Non-Urgent Crossing Status: Not Found UCIP Comments: no markers or signs available--will need to coordinate with owner to determine if crossing is still being used or abandoned. FIELD_STRUCT_DESC: 12-inch steel gas line through the levee. Facility on landward side. FS Date: 05/14/2013	38.111078 ° -121.682011 °	38.111078 ° -121.682011 °	17

Levee Mile Report Line	15
Start Levee Mile	0.17
End Levee Mile	0.17
Location	Crown
Category	Earthen Levee
Item	Erosion / Bank Caving
Looking south at erosion on waterside toe.	
richard_f_20130911_208.JPG

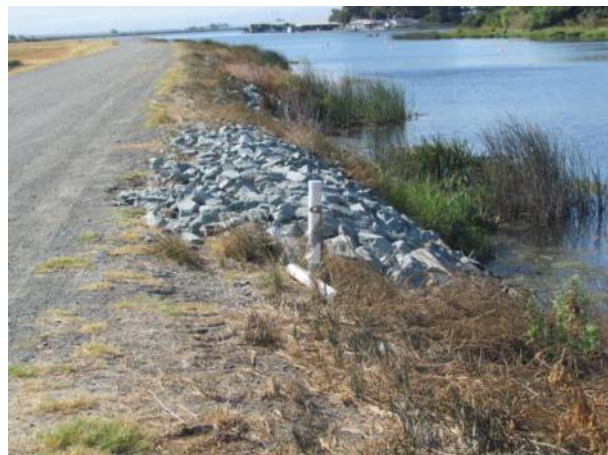
Levee Mile Report Line	15
Start Levee Mile	0.17
End Levee Mile	0.17
Location	Crown
Category	Earthen Levee
Item	Erosion / Bank Caving
Looking south at repaired erosion site on waterward slope.	
richard_f_20130913_214.JPG

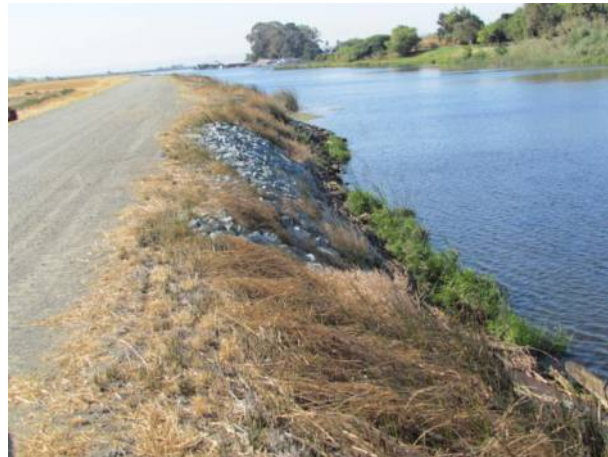
Levee Mile Report Line	16
Start Levee Mile	0.18
End Levee Mile	0.18
Location	Crown
Category	Earthen Levee
Item	Erosion / Bank Caving

Looking southwest at repaired site on waterward slope

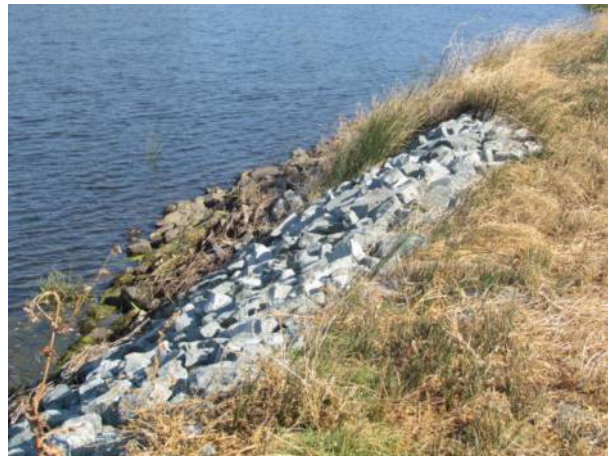
Levee Mile Report Line	16
Start Levee Mile	0.18
End Levee Mile	0.18
Location	Crown
Category	Earthen Levee
Item	Erosion / Bank Caving

Looking northwest at repaired erosion site on waterward slope.

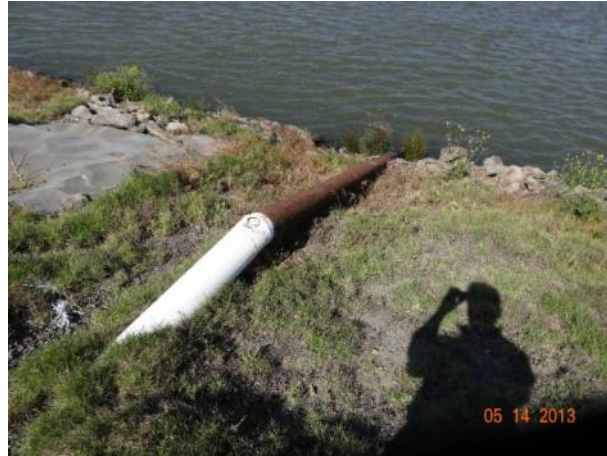
Levee Mile Report Line	18
Start Levee Mile	2.08
End Levee Mile	2.08
Location	Crown
Category	Supplemental
Item	DWR UCIP Field Study

DWR ID: DWR_RD1601_01_f_2013_17										
18	2.08	2.08	Supplemental	DWR UCIP Field Study	CR	M En	Inspector Comments: FS_ID:19524 EP_NO: 2909A Repair Type: Non-Urgent Crossing Status: Found UCIP Comments: FIELD_STRUCT_DESC: 8-inch siphon pipe through levee, 2.4 feet below crown. Cutoff wall around pipe at center of levee. Siphon breaker on apex of pipe on landward shoulder. Hand primer pump on landward slope. (Permit No. 2909A-1960) FS Date: 05/14/2013	38.093107 ° -121.684525 °	38.093107 ° -121.684525 °	18 Y
DWR ID: DWR_RD1601_01_f_2013_18										
19	2.08	2.08	Supplemental	DWR UCIP Field Study	CR	M En	Inspector Comments: FS_ID:19515 EP_NO: 2909A Repair Type: Non-Urgent Crossing Status: Found UCIP Comments: FIELD_STRUCT_DESC: 8-inch siphon pipe through levee, 2.4 feet below crown. Cutoff wall around pipe at center of levee. Siphon breaker on apex of pipe on landward shoulder. Hand primer pump on landward slope. (Permit No. 2909A-1960) FS Date: 05/14/2013	38.093107 ° -121.684525 °	38.093107 ° -121.684525 °	19

View of crossing on waterward slope. Rip rap present at waterward toe.

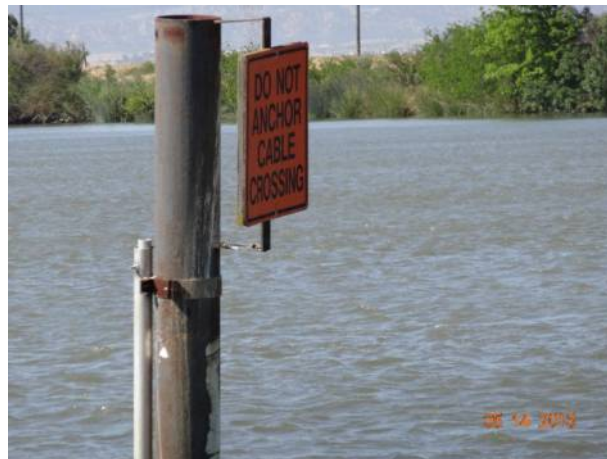
Levee Mile Report Line	24
Start Levee Mile	2.13
End Levee Mile	2.13
Location	Crown
Category	Supplemental
Item	DWR UCIP Field Study

LMR No.	Levee Mile		Category	Item	Location *	Rating **	Action/Comment	GPS Latitude/Longitude		Issue No.
	Start	End						Start	End	
24	2.13	2.13	Supplemental	DWR UCIP Field Study	CR	M En	Inspector Comments: FS_ID:19525 EP_NO: 6297 Repair Type: Non-Urgent Crossing Status: Found UCIP Comments: FIELD_STRUCT_DESC: 3-inch electrical conduit through levee, 5.0 feet below the crown. Location marker on waterward slope. Rock revetment on waterward slope. (Permit No. 6297-1969) FS Date: 05/14/2013	38.092427 ° -121.684595 °	38.092427 ° -121.684595 °	24 Y

Sign present on waterward side.
